SparView™ Vol. 5, No. 17, August 15, 2007 ISSN 1553-8834
Business and technology trends in capturing and managing existing-conditions data for engineering / construction / operations

Laser Scanning Space Shuttle Endeavour

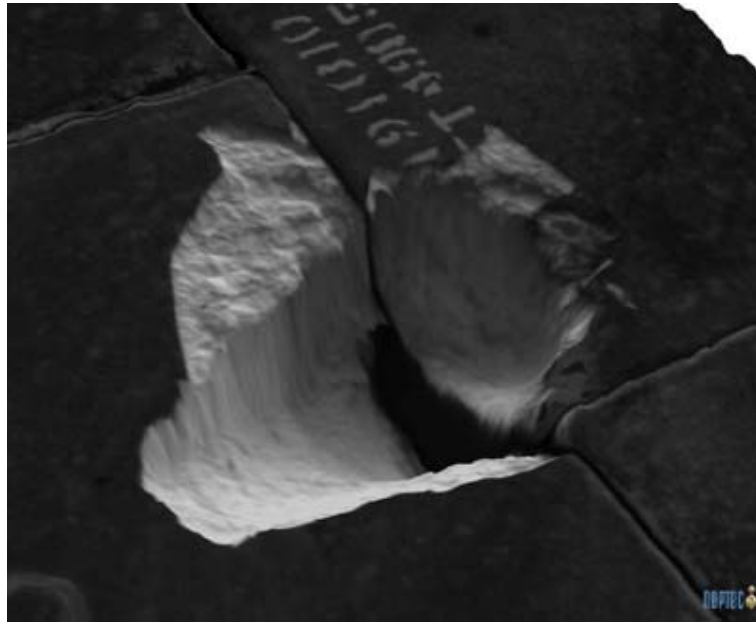
Figure 1: 3D scan of damage to Endeavour's protective tiles captured with Neptec's Laser Camera System. Images courtesy Neptec Design Group

"That was designated a 'priority focused inspection area,'" Christie says, "so NASA had the astronauts set up the LCS to capture high-resolution scans and take multiple images" of the damaged area. Once the scans were downloaded from the shuttle, Neptec transformed the data from the scanner's spherical coordinate system to an x,y,z-format point cloud. Then Christie says Neptec used its LCS Analysis Tool software and [PolyWorks](#) to measure the damage, especially the critical question of how deeply the tiles were penetrated. All this data was then transmitted to NASA for further analysis. "At the end of the day," Christie sums up, "the mission management team gets a report based on accurate 3D data."

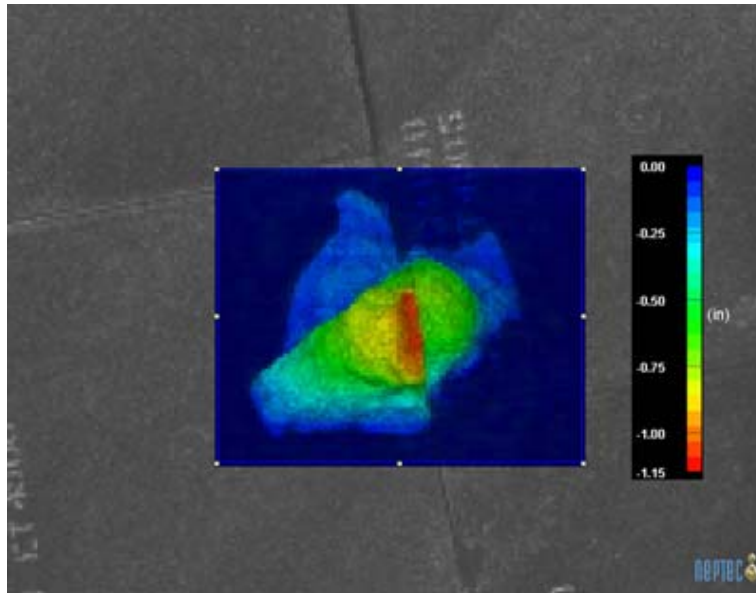
Figure 2: False-color scan of damaged area – deeper damage is color-coded red. Image courtesy Neptec Design Group

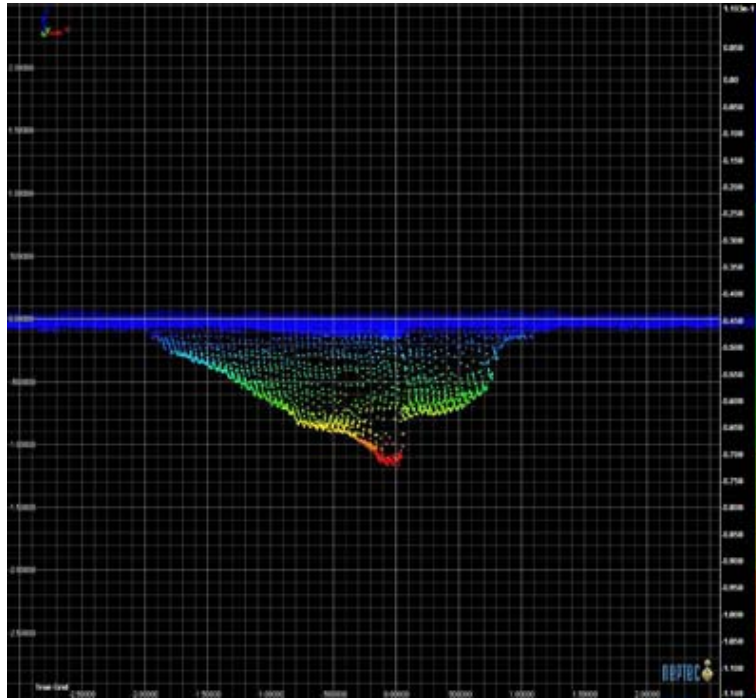
Figure 3: Side profile showing depth of tile damage – 3D model created from scan data. *Image courtesy Neptec Design Group*

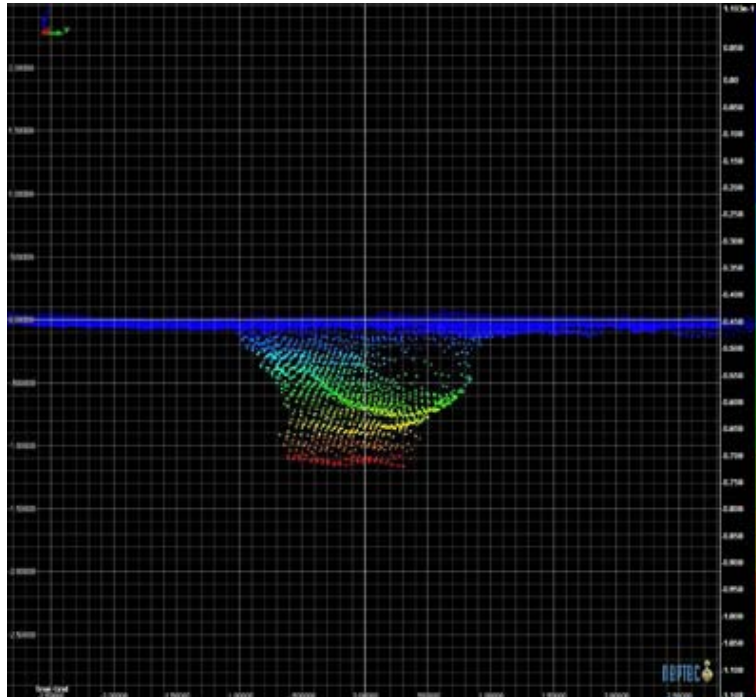
Figure 4: End profile showing depth of tile damage – 3D model created from scan data. *Image courtesy Neptec Design Group*
